STORABILITY INVESTIGATIONS OF WATER
LONG-TERM STORAGE EVALUATION

Aerojet Liquid Rocket Company

Air Force Rocket Propulsion Laboratory

December 1974

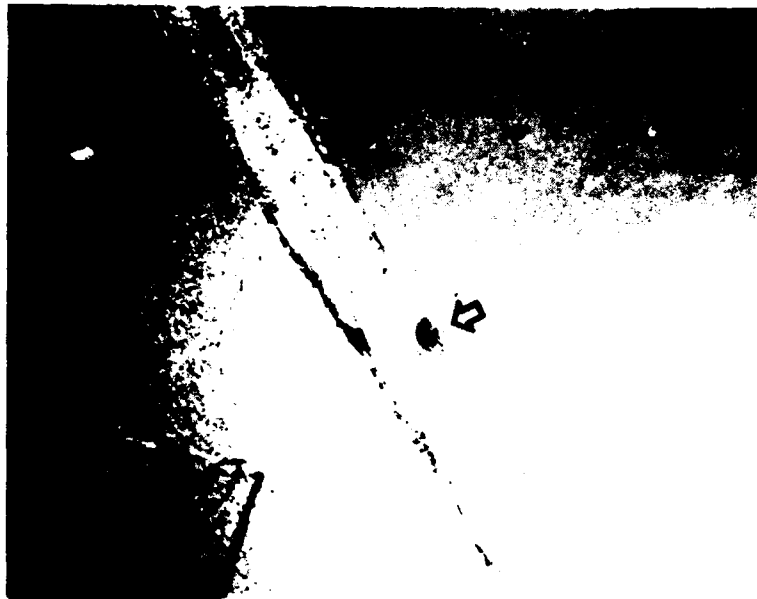
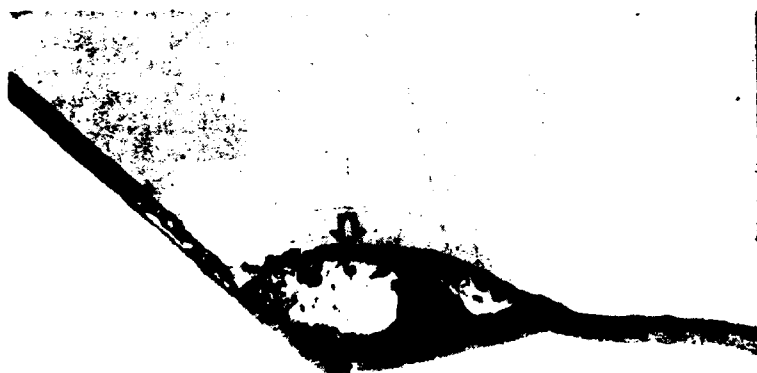
The one discrepancy found in the 304 containers was a small piece of opaque refractory-appearing material in the weld of Containers No. 3 and 5, Figure 16. The small size prevented identification by chemical or instrumental analyses. A metallographic specimen was prepared from No. 3 container; however, most of the material was lost during specimen preparation due to brittleness. In addition, a light red stain appeared adjacent to the closure weld of container No. 11. The cause of the stain could not be determined; its size was 0.15 x 0.01 inch.

Figure 16. Opaque Appearing Contaminant in Closure Weld of 304 No. 3 Container (Arrows), Section of Weld Taken Through Contaminant (lower Photo). Most of Contaminant was Lost During Sectioning Due to Brittleness.

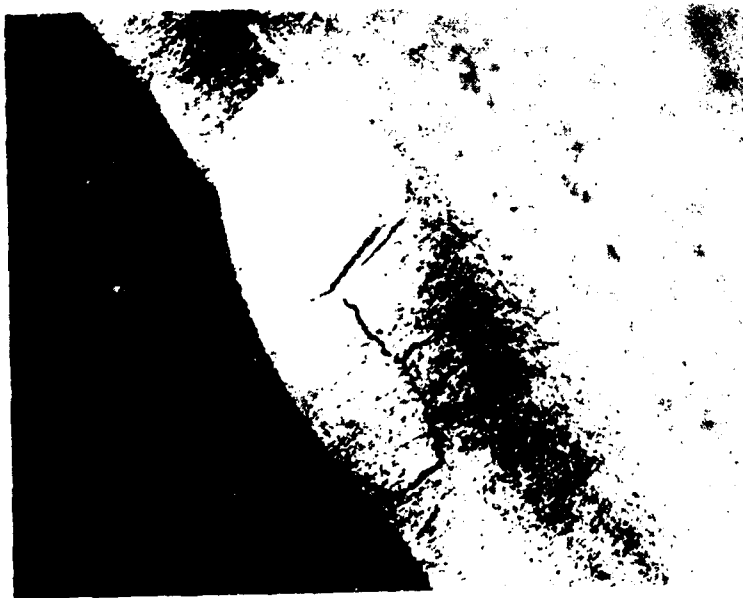
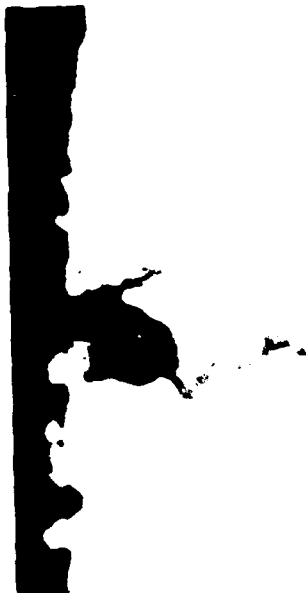
A total of four cracks were found in the end closure welds; one crack appearing in Containers No. 13 and A-3, and two cracks appearing in Container No. 6. Three of the cracks are shown in Figures 17 through 19. The cracks appear in both the oxygen-free and oxygen-saturated water containers and are attributed to shrinkage stresses occurring during the welding process. These defects were expected, due to the poor weldability of the A-286 material. The photomicrographs indicate a corrosive attack of either part or all of the weld crack. This behavior is attributed to crevice corrosion during post-heat treatment pickling of the containers. The presence of scale within the crack prior to heat treatment verifies the conclusion that the attack is not a result of water storage. No evidence of corrosion resulting from water storage could be found.

Figure 17. Weld Crack in A-286 No. 13 Container. Photomicrograph (right) Shows Heat Treatment Scale in Lower Portion of Crack. Crack at Surface Been Enlarged by Crevice Corrosion During Pickling.

The presence of contaminants in the titanium alloy containers prior to heat treatment and the weld cracks found in the A-286, Inconel 718, and 17-4PH stainless steel containers are attributable to inadequate process control on the part of the container supplier. In spite of the presence of the contaminants, the water quality was not significantly impaired.

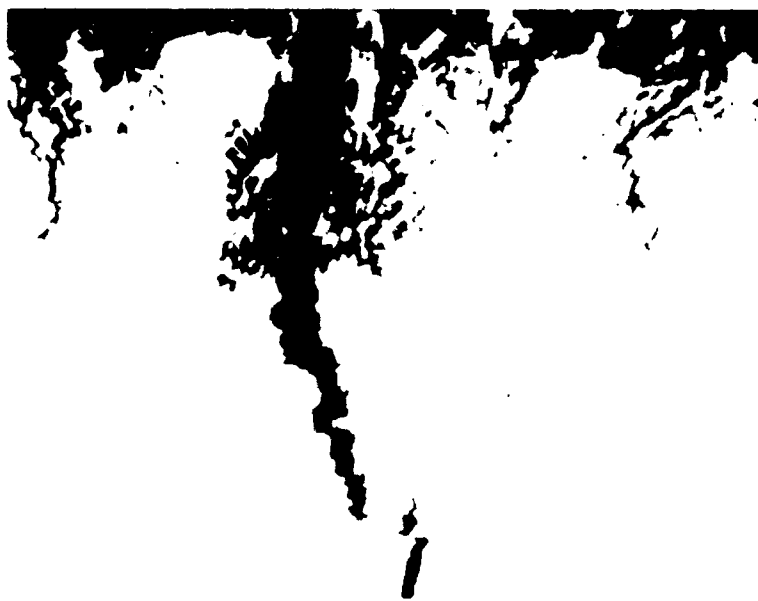
Figure 19. Weld Crack in A-286 No. 3 Container. Photomicrograph (Bottom) Shows Upper Portion of Crack Enlarged Due to Crevice Corrosion During Pickling.
